Mariusz Ziejewski, Ph.D., Inż.

June 20, 2018

RE: Ms. K [REDACTED] M [REDACTED] F [REDACTED]

Pursuant to your request, I am setting forth my biomechanical opinions regarding the motor vehicle accident on March 17, 2014, involving K [REDACTED] F [REDACTED]. I am also providing a summary of my background and qualifications to render my opinions.

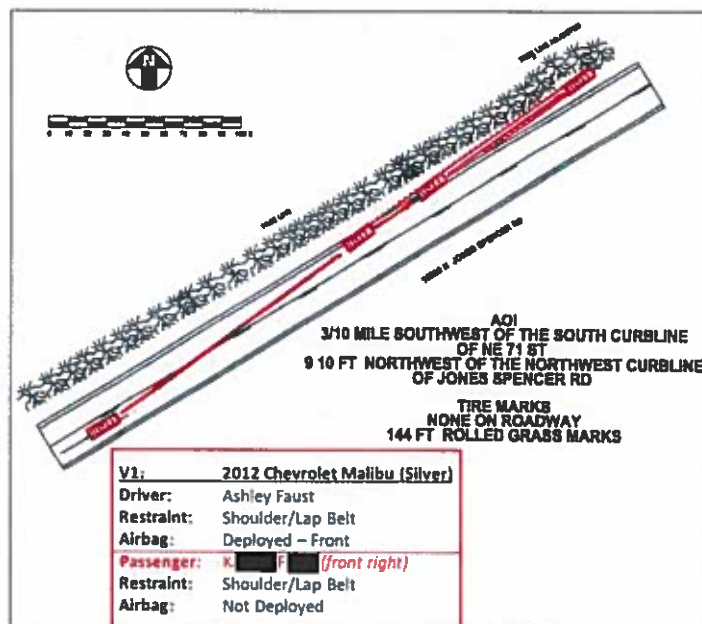
Figure 2 – 1st Incident Accident Diagram (Color and Labels Added)

“Unit 1 was traveling in a north east direction on Jones Spencer Road. Unit 1 driver crossed the center line and was driving in the south west lane. Unit 1 continued in the north east direction right of the center line. Unit 1 departed the roadway and collided with a tree. At this time it is not clear why the driver departed the roadway.”

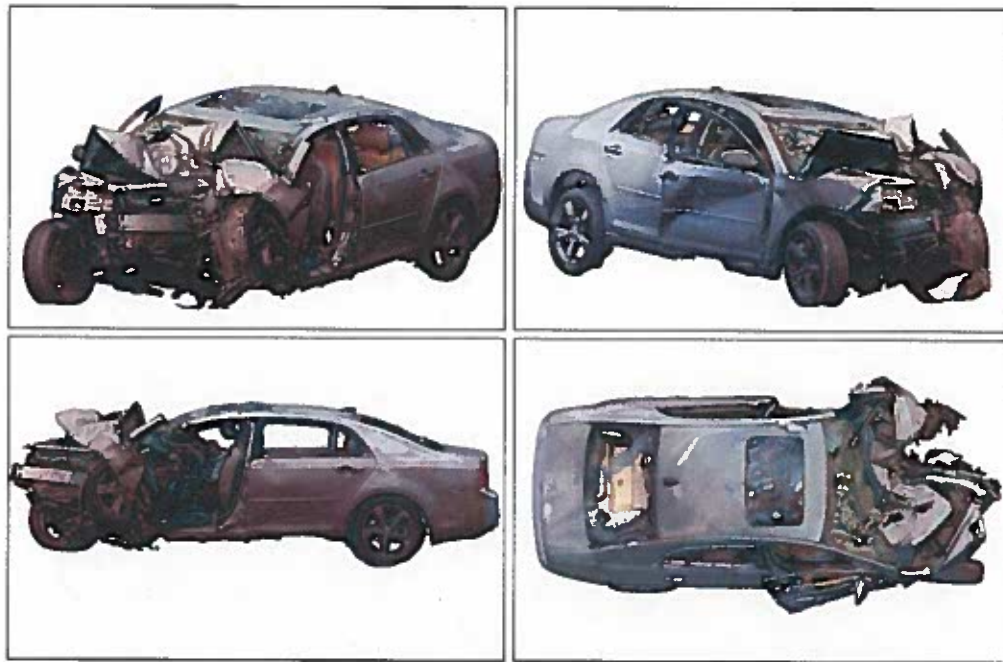
Figure 7 – 3D FARO Laser Image for the 2012 Chevrolet Malibu

My inspection of the subject Chevrolet Malibu vehicle revealed extensive damage consistent with a frontal offset impact with a tree. From a trauma biomechanics perspective, in this case, the most relevant areas of damage included but were not limited to, the front bumper area and hood of the vehicle. Based on the nature and extent of the Chevrolet Malibu's damage, it is obvious the structural components were subjected to compressive forces exhibited by dynamic progressive buckling characteristics. The subject of

The damage assessment for the Chevrolet Malibu was carried out using two different approaches: laser-based measurements and basic measuring tools. Selected images from the 3D FARO Laser System and photographs taken during my inspection are shown in Figures 7 and 8.

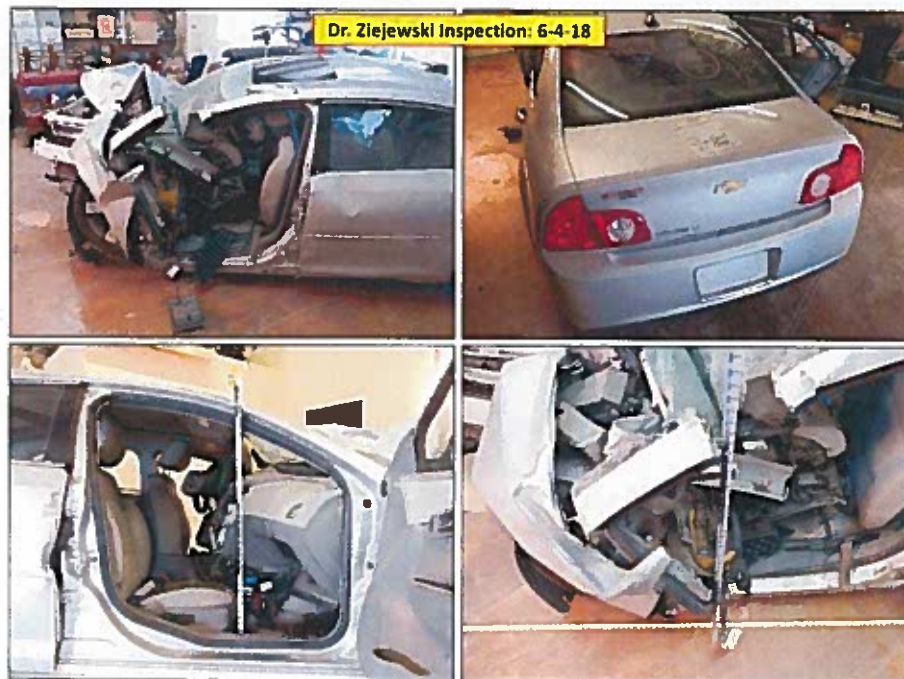
Figure 8 – Selected Photos of 2012 Chevrolet Malibu

Since the front passenger's survival space was relatively maintained, (Figure 8 previously), and the driver (with properly functioning restraint systems) survived the incident, one can conclude Ms. K■■■■ F■■■■'s injuries were the direct result of the airbag non-deployment and excessive forward excursion.

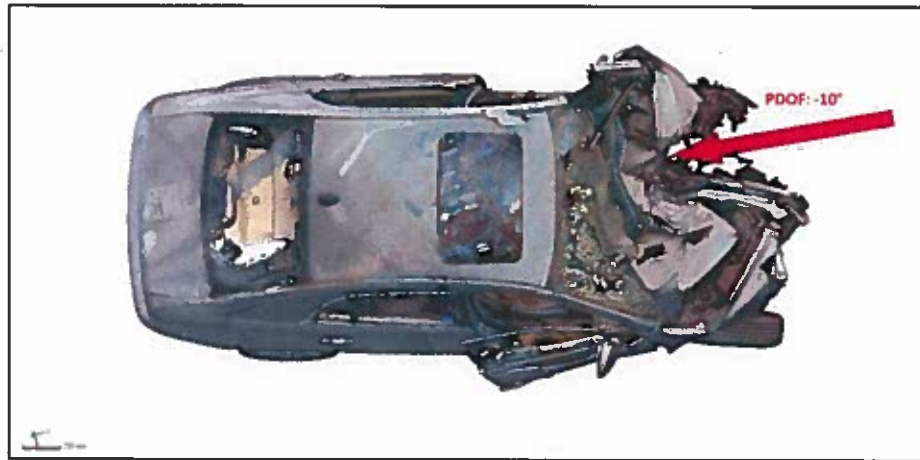
Figure 9 - Principal Direction of Force

The Principle Direction of Forces (PDOF) of -10 degrees (10 degrees to the left) is shown in Figure 9.

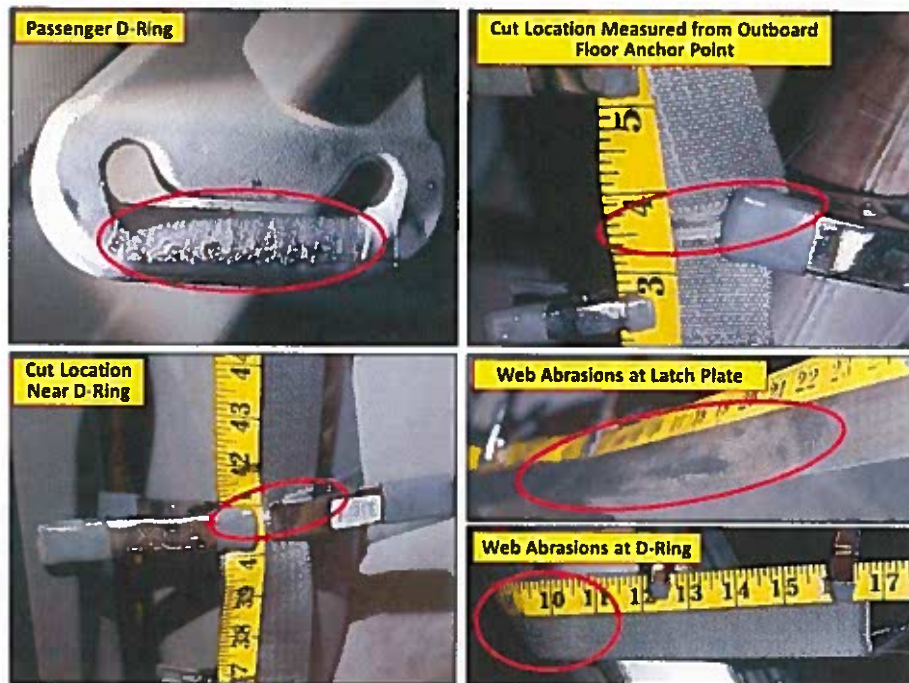
Figure 17 – Passenger Seatbelt Load Marks

According to the Oklahoma Traffic Collision Report, the CDR, and Ms. Faust’s medical records (Materials Studied #1, #2, and #4a-c respectively) Ms. Faust was properly belted at the time of the incident. Marks consistent with belt loading were present (Figure 17) with polymer flow observed on the D-ring, cuts noted at approximately the 3 ½-inch mark and 41-inch mark, as measured from the outboard floor anchor respectively. Web abrasions were observed at approximately 13 – 22-inches from the outboard seat belt anchor and up to 10-inches from the D-ring.

1. Safety Belt
 - a. Load limiters with a stop.
 - b. Utilize an adaptive load limiter.
 - c. Utilize a higher force on the load limiter as was done for the 2008-2010 Chevrolet Malibu.
2. Seat Design
 - a. Utilize the patented design by Hyundai that eliminates the need for a mat on the seat cushion and instead uses load sensors on the seat frame.
3. Occupant Classification System
 - a. Utilize a design that uses load sensors on the seat which do not cause interference with the seat cushion or affect anti-submarining effectiveness.

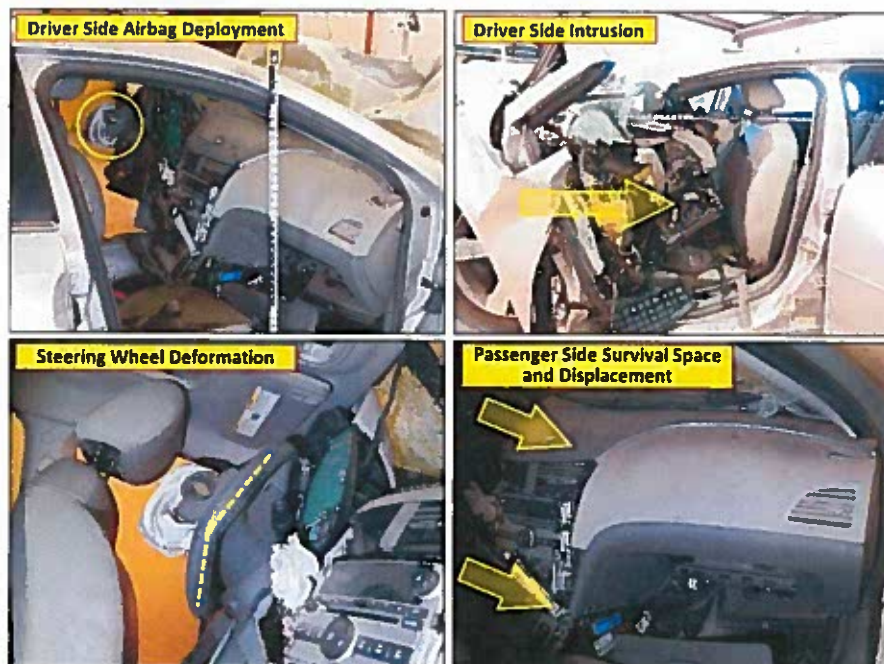
Figure 18 – Interior Vehicle Inspection

Vehicle inspection indicated deployment of the driver's side front airbag but not the passenger side. Intrusion was noted to be >12 inches on the driver's side with steering wheel deformation. Passenger side survival space was relatively maintained with a rightward shift (towards passenger door) of the dash and instrument panel (Figure 18).
